NASA CR-134712  
PWA™-5022

# IMPACT RESISTANCE OF HYBRID COMPOSITE FAN BLADE MATERIALS

Pratt & Whitney Aircraft  
Division of United Aircraft Corporation

Contract NAS3-17789

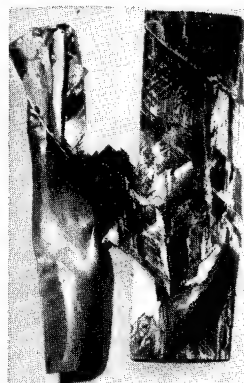
Figure 27 Loss of Torsional Rigidity for Blade Specimens Impacted with 2.54 cm Diameter Gelatin at 275 m/sec 30° to the Blade Chord

IMPACT ANGLE 30°

The loss of torsional rigidity of the various configurations is summarized in Figure 27.

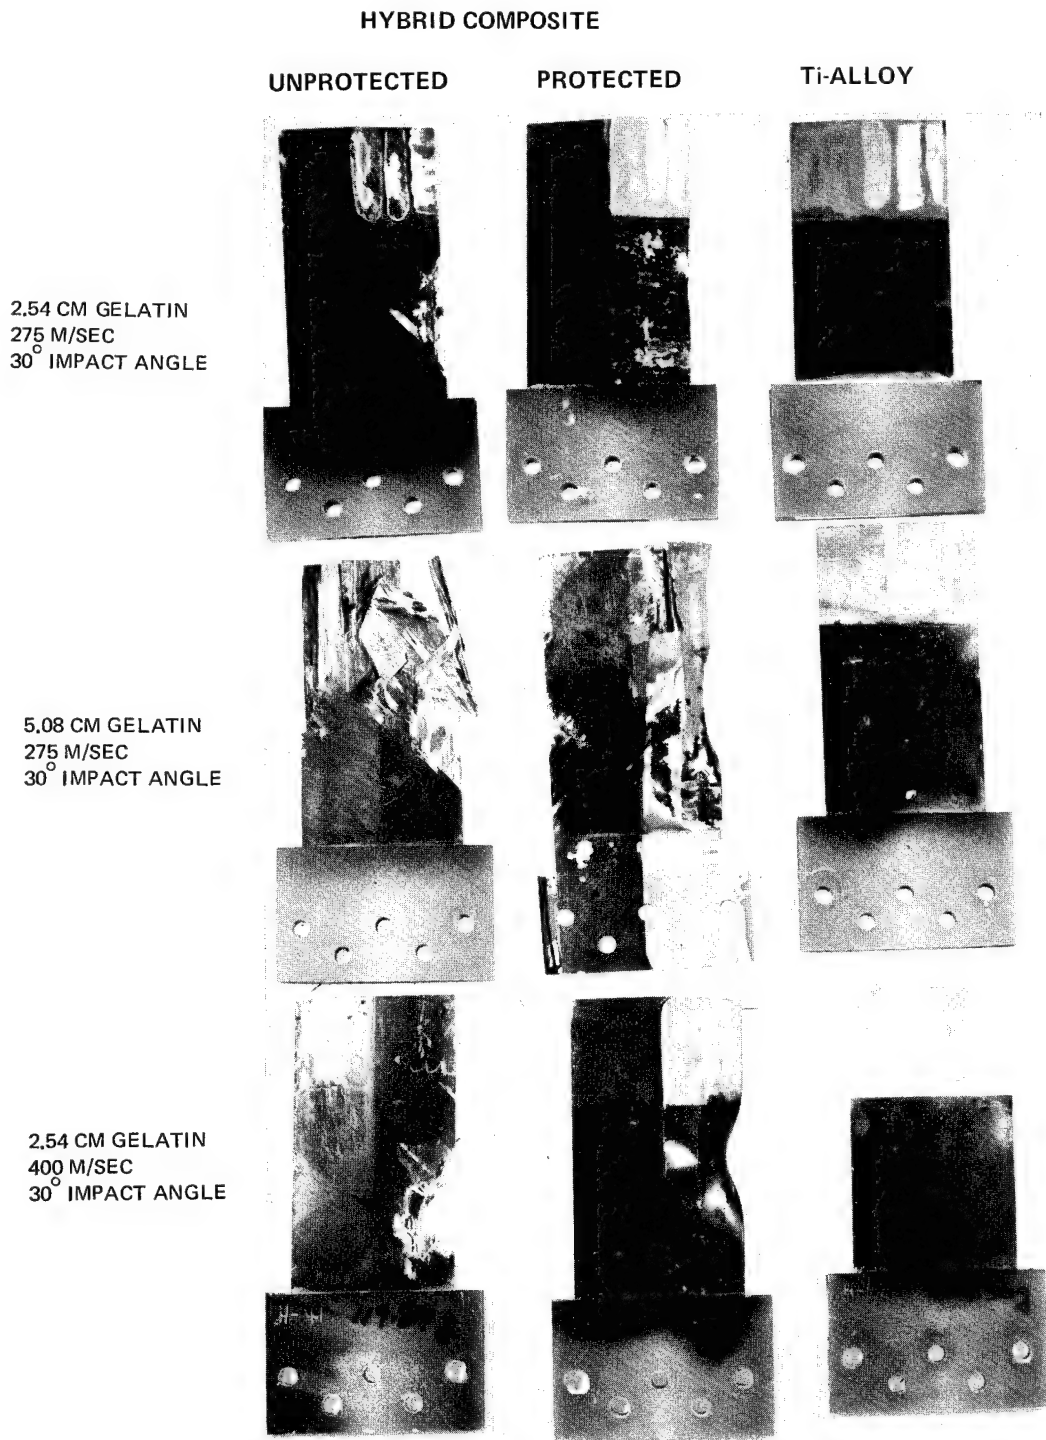
Figure 29 Results of Spin Impact Testing of Hybrid Composite and Titanium Alloy Simulated Blades

Spin impact testing resulted in less severe damage than bench impact testing. The absence of high speed motion pictures of the spin impact tests precluded a definite conclusion as to whether comparable impacts had occurred in both the spin and bench tests.
